REVIEW ARTICLE

Lead service line identification: A review of strategies and approaches

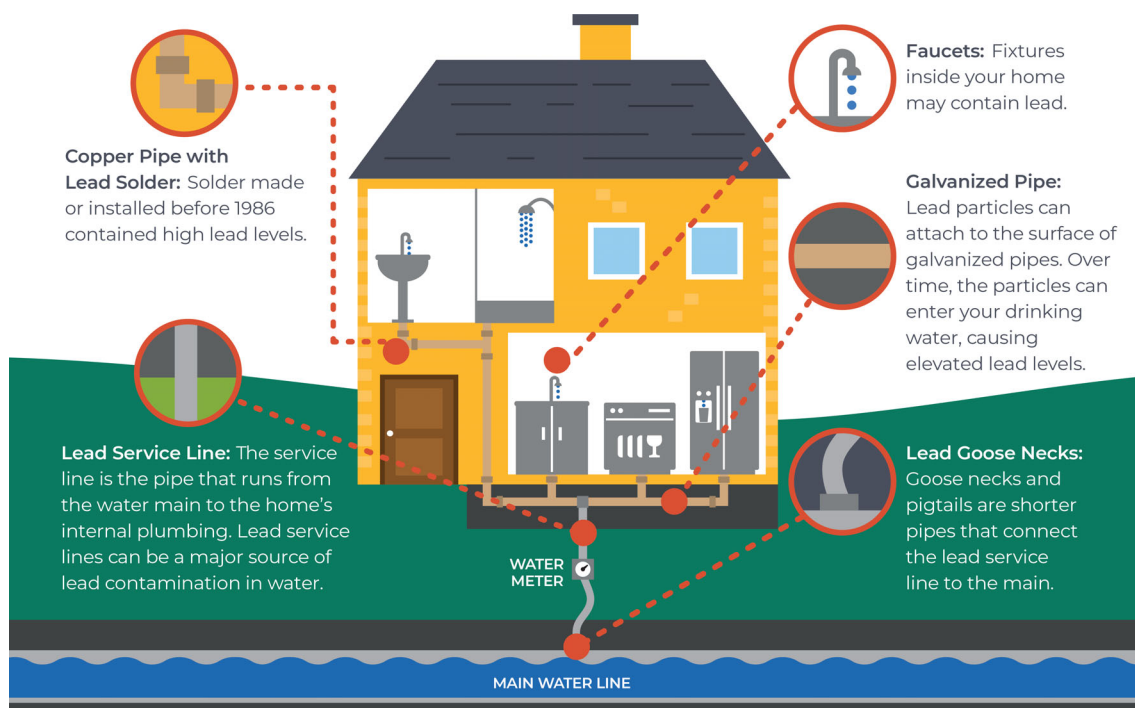
FIGURE 1 Sources of lead in drinking water (U.S. Environmental Protection Agency, 2017)

Lead in the dissolved and particulate forms can enter consumers' drinking water from interior and exterior house sources (Figure 1). Plumbing lead sources include lead-containing plumbing fixtures (e.g., lead brass faucets), lead pipe, galvanized pipe (Sandvig et al., 2008), and lead soldered joints (Quevauviller & Thompson, 2006). Exterior pipes, or service lines (SLs), supply a home with drinking water from the utility's water main. All or part of the SL may be the

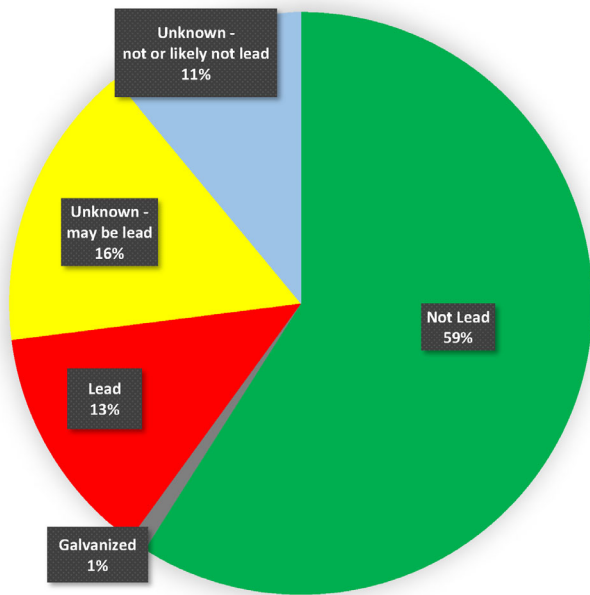
FIGURE 2 Reported average service line estimates in four states, publicly available from Michigan EGLE (March 2020), Illinois EPA (June 2020), Wisconsin PSC (July 2020), and Indiana (via EDF, July 2018). Includes a total of 9.78 million service line materials, compared with 9.83 million service connections reported to safe drinking water information system (SDWIS) for active community water systems (CWS) in these four states. See Table S1 for additional details including data sources. For Indiana, lead goosenecks were included in the lead category

On the basis of Table S1, the 2016 national survey by Cornwell et al. (2016) estimated 25% more LSLs in IL, IN, MI, and WI than the most recent state-reported LSL estimates (excluding unknowns). Many uncertainties exist in these data sets. For instance, if the unknown materials are included in the LSL count as presumed lead, then the 2016 LSL estimate would be 61% lower than the four state estimates. Despite uncertainties, these statewide estimates shed light on the scope and extent of the LSL replacement challenge at the local, state, and national levels, but these estimates could not be used to identify the specific homes needing LSL replacement. Overall, the many uncertainties in current estimates and inability to extrapolate national survey results to the local scale (Cornwell et al., 2016) necessitate more accuracy at the national and local levels.

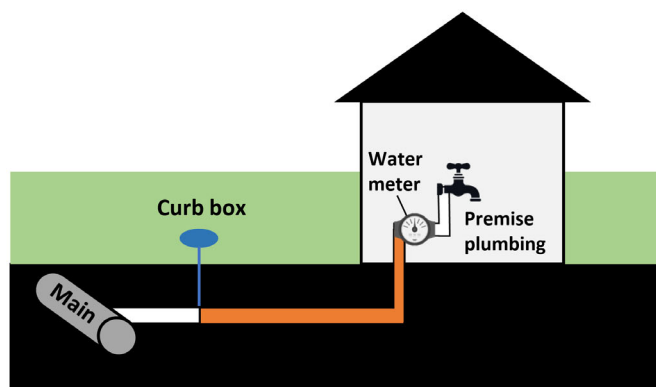
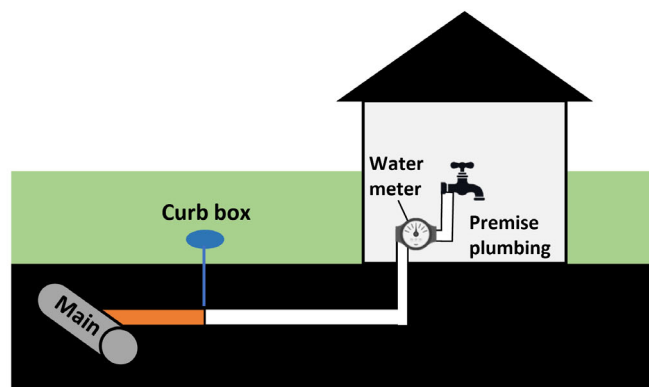
(a) Privately-owned LSL (homeowner responsibility)

(b) Publically-owned LSL (utility responsibility)

FIGURE 3 Typical example of privately owned and publically owned lead service lines based on curb stop division (modified diagram from Deshommes et al., 2016). Water meter may be located outside or inside the building. For some materials, a gooseneck may be present, connecting the water main and the publicly owned service line

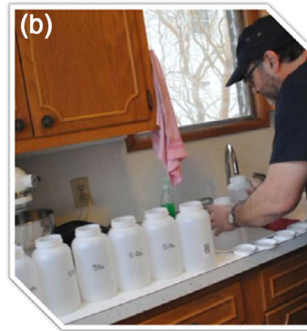
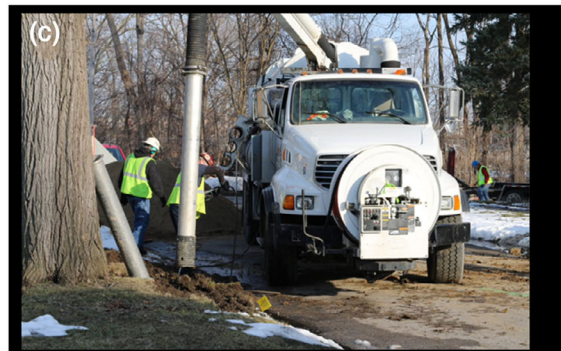
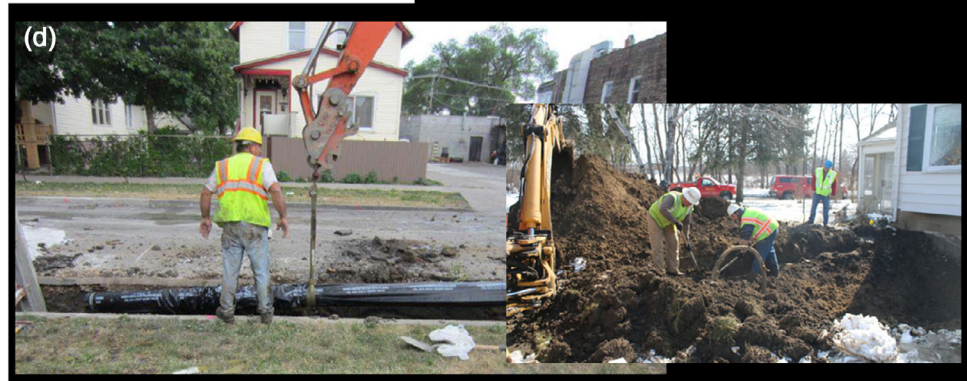
(a)

LSLs identified

Water Quality Sampling

Excavation

- SL installation records (Figure 4(a))
- Inspection and maintenance records, including replacement or repairs of specific SLs and larger water main replacement projects
- Plumbing permits
- Meter installation records
- Property tax records
- Distribution system maps and drawings, including as-built drawings

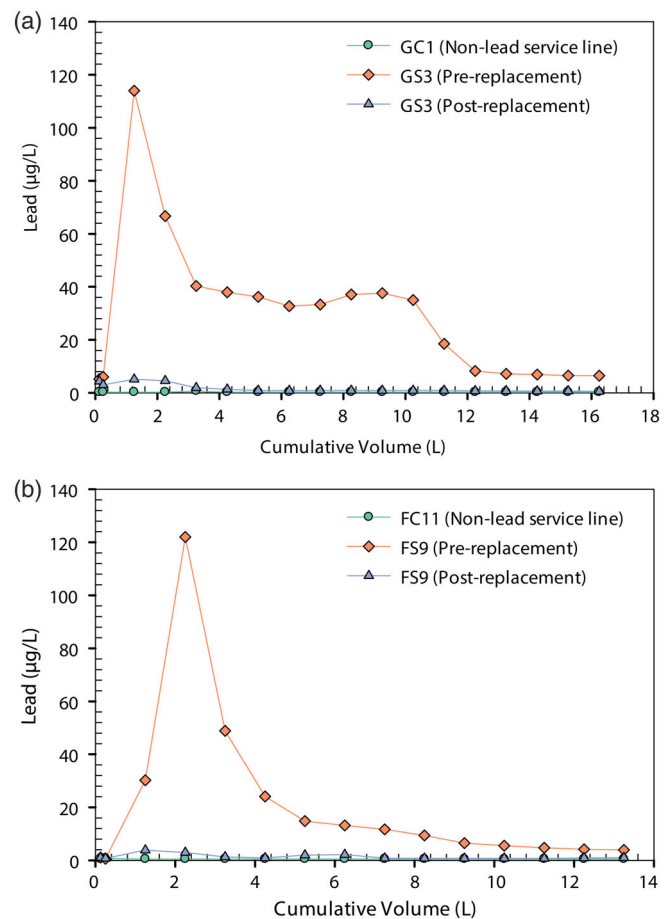
FIGURE 5 Examples of sequential sampling of lead profiles in homes of two cities (a and b). Profiles were obtained in homes before and after lead service line replacement, and in homes that never had a lead service line. The illustrative trends are meant to indicate lead service line presence or absence. The exact lead concentrations are specific to the sampled homes. They should not be generalized to reflect other homes, which may have different plumbing and/or water chemistry characteristics

Elevated lead concentrations in a sequential profile can be used to identify the location of lead sources, including LSLs, by comparing profile characteristics in a pool of sites that have never had an LSL with a pool of sites that are certain to have LSLs. Figure 5 shows illustrative sequential lead profiles for LSL identification in two anonymous communities. Profiles were obtained in LSL sites pre- and post-removal, as opposed to control sites that never had an LSL. Peak lead concentration in the profiles or average lead mass of all samples collected in the profiles can be compared to establish a threshold lead concentration that can be used to identify locations with LSLs among the unknown locations (James et al., 2019). James et al. (2019) reported the use of thresholds based on three times the average sequential lead peak concentration in a pool of representative non-LSL sites in two communities. Compared with the pools with known LSLs sites, 100% of 16 LSLs locations and 78% of 10 LSLs evaluated in community 1 and community 2, respectively, had peak lead levels above the threshold (i.e., the presence of the LSL was accurately predicted). The higher false-negative rate (LSLs with results below the threshold) in community 2 is thought to be due to good community-wide corrosion control. Thresholds established from three times the weighted lead sequential averages in representative non-lead sites in each CWS predicted 100% of LSLs in both communities on the basis of the individual sites' lead sequential averages. In the same communities and sites, 5MF accurately predicted only 63% and 11% of the LSL sites in community 1 and community 2, respectively. Although more time-intensive and costly, sequential sampling was a much more sensitive tool for identifying LSLs as compared with 5MF sampling.

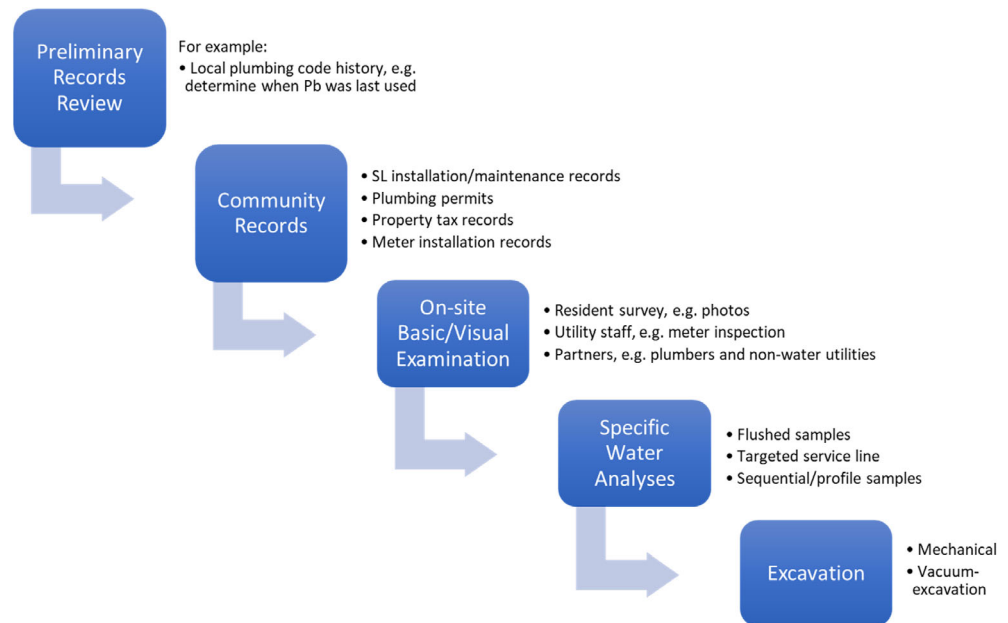
FIGURE 6 Suggested stepwise service line identification approach. Adopting the approach in its entirety assumes availability of resources

Overall, the goal of the water utility is to conclusively identify all unknown SL material, on both public and private property, while considering costs, disruptions, method reliability, and other factors. A stepwise SL identification approach that begins with the simplest, least invasive, and least expensive SL identification method and evolves toward more complicated, costly but more certain methods can help utilities effectively reach this goal (Figure 6). Such an approach would aim to identify and thus remove some LSLs from the unknown SL pool in each step, while forwarding the remaining unknown SLs to the next method or step until all the unknown SLs are ultimately identified. An SL would be removed from the unknown pool (classified as lead) only if a method strongly indicated it to be an LSL. However, if a method's results are compelling enough and all decision makers agree, SLs could be removed from the pool (classified as

non-lead) if results strongly indicate that the SL is not made of lead.

The SL identification sequence of steps should begin with determination of a date threshold for LSL installation, community records, and visual/basic examination. Depending on the quality of historical records, an additional data source may be necessary to enhance confidence during this first step. These records may be used to create statistical or geospatial models to assist in prioritizing additional identification methods. Utilities may then consider an appropriate water sampling approach (e.g., flushed or sequential samples associated with system-specific lead concentration thresholds) as the next step toward identifying unknown SLs, followed by excavation as a final step, if needed. Considering the pros and cons of each step (Table 2), this suggested stepwise approach could be modified to account for the variable needs and constraints of different utilities. Overall, as additional LSL identification methods are developed and used, and as utilities gain and share more experiences with existing tools, better practical understanding will be achieved.
